Sandy is a 68 yo WF with greater than 20 history of multiple sclerosis and 1.5 year history on non-healing fracture of the base of the fifth metatarsal (outside foot bone). She had already tried immobilization and had very low activity levels. Non-union was believed to be due to poor blood flow in the affected extremity. Cells were obtained, isolated, and culture expanded and then injected into the fracture site under CT planned fluoroscopy. After 2 months, she noted resolution of nagging pain in the area. Thin slice CT was taken before the procedure and 9 months after the procedure.

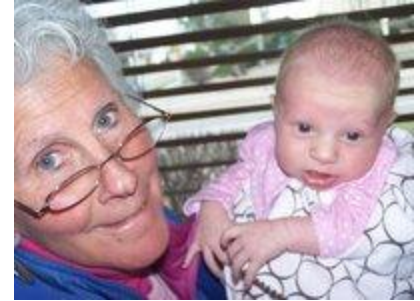
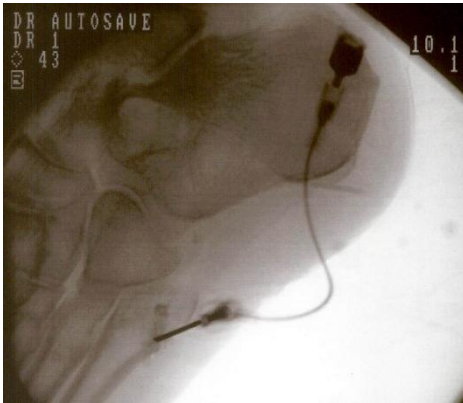
The fracture site being injected with stem cells under thin slice CT planned fluoroscopy (real time x-ray). Note that some cells were injected into the fracture area, while others were simply placed in the general fracture region. If this injection based treatment were not successful, then the next step would have been surgically re-breaking the bone and installing plates (ORIF).

**IMPRESSION: INCOMPLETE HEALING OF THE FRACTURE OF THE BASE OF THE LEFT FIFTH METATARSAL BONE, ALTHOUGH THE ALIGNMENT IS ANATOMIC.**

- 1. No new fracture. The fifth metatarsal base fracture line is only faintly visible along the lateral aspect and is otherwise healed.**
